# Manhole Inspection Summary

Manhole # S17QQ1044MH

Insp Date: **6/27/07 9:02 AM**

**Location** Address: **TAMARIND RD**

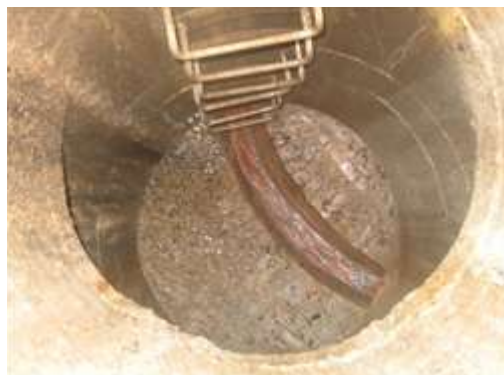
Top View

Bench debris.

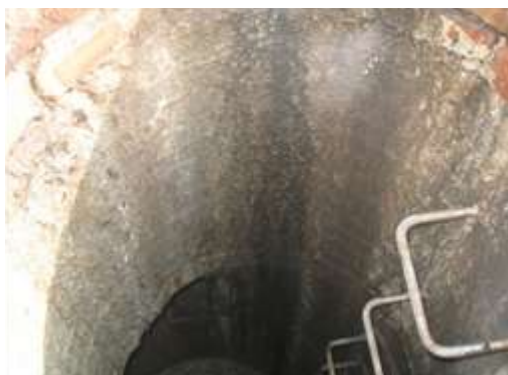
Defect

**Frame** Offset: **0** (in.) Condition: ☐ Sound ☐ Cracked ☒ **Leaks**

Condition: ☐ Sound ☐ Cracked ☐ Root Intrusion ☐ Loose Brick ☒ **Deteriorated**

Infiltration: ☐ None ☒ **Joint** ☐ Cracks ☒ **Mortar** ☐ Roots ☐ Wall

Frame leaks. Adjustment deterioration and infiltration.

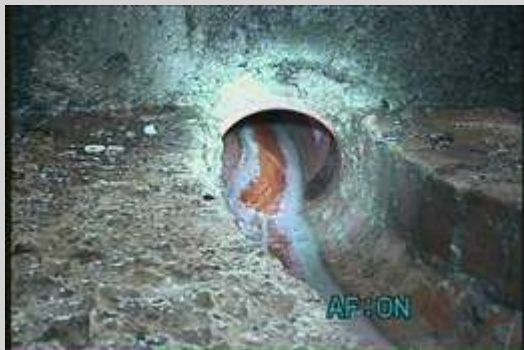
### 8 in. Circular Gravity Sewer Pipe Out @ 12 O'Clock

Invert Depth: **11.58** (ft.) Flow Characteristics: **Fast**

Deposits: ☒ None ☐ Mud ☐ Sludge ☐ Debris ☐ Grease

Infiltration: **None** Pipe Seal Cond: **Unknown**

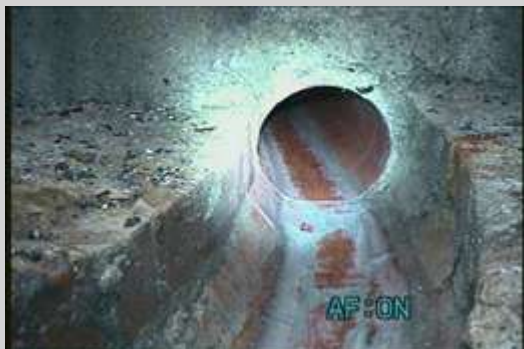
### 8 in. Circular Gravity Sewer Pipe In @ 5 O'Clock

Invert Depth: **11.44** (ft.) Flow Characteristics: **Fast**

Deposits: ☒ None ☐ Mud ☐ Sludge ☐ Debris ☐ Grease

Infiltration: **None** Pipe Seal Cond: **Unknown**
